Bungalows to Mansions

Inspection Report

1322 SW 7th Park Avenue
Ocala FL 34486

Date: 11/11/2014	Time: 11:00 AM	Report ID: sample commercial
Property: 1322 SW 7th Park Avenue Ocala FL 34486	Customer: sample Inspection	Real Estate Professional:

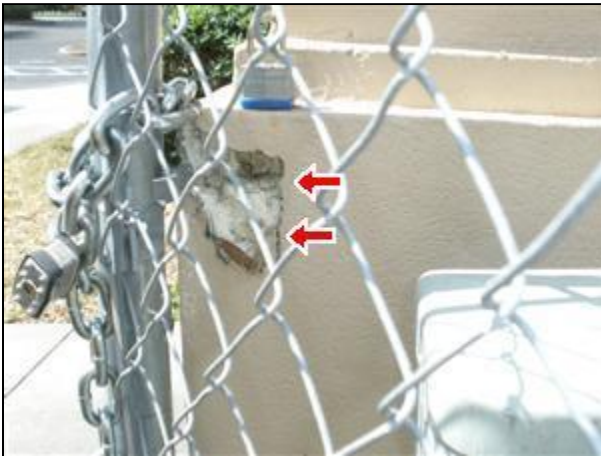
1.0 Picture 1

1.0 Minor damage to the EIFS trim near the electrical meter. Recommend repairs as needed.

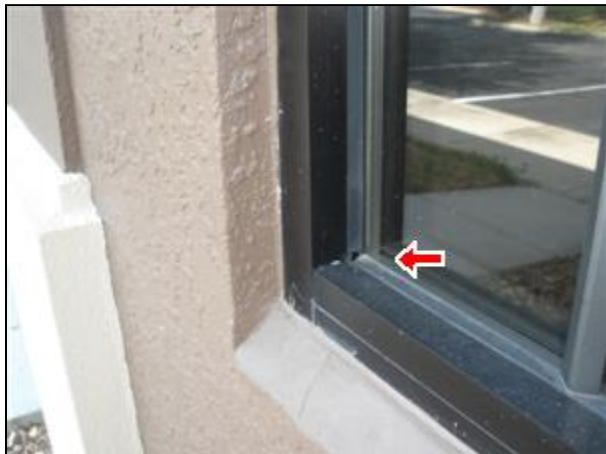
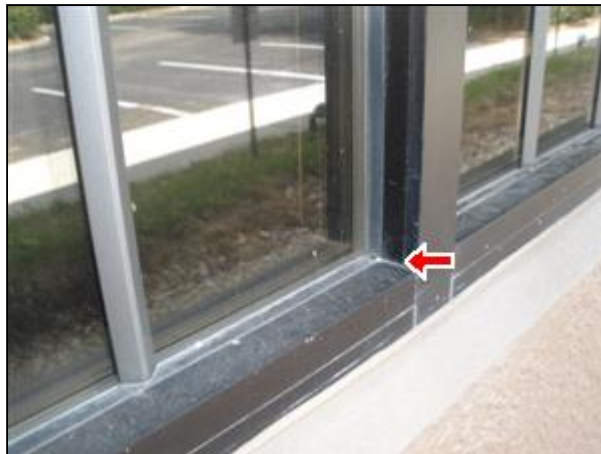
1.2 Picture 1

🏠 1.2 Several of the weather seals have shrunk and can allow for moisture intrusion. Recommend repairs as needed by a certified window contractor.

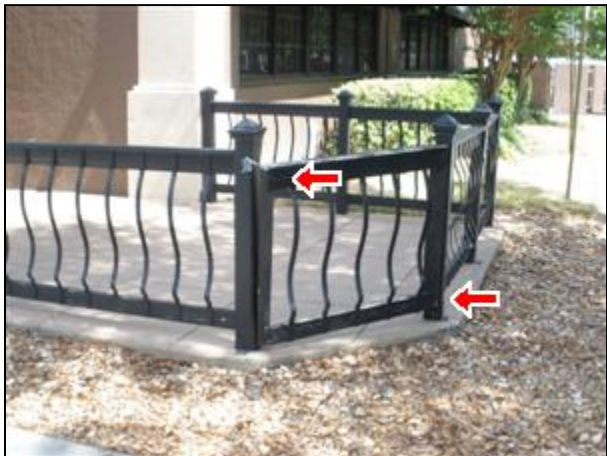
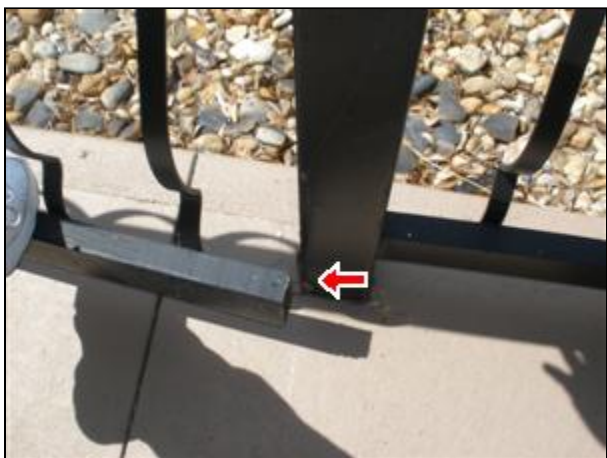
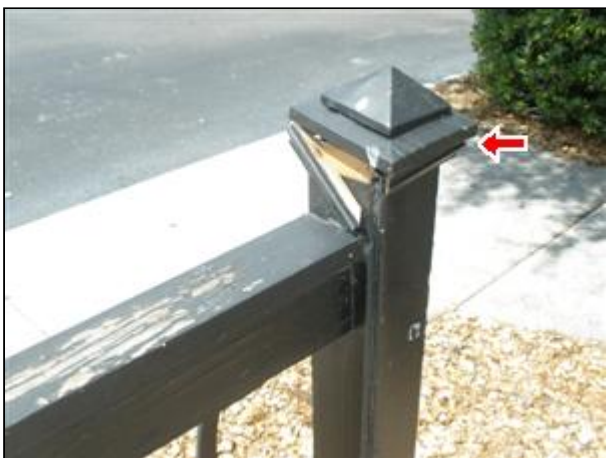
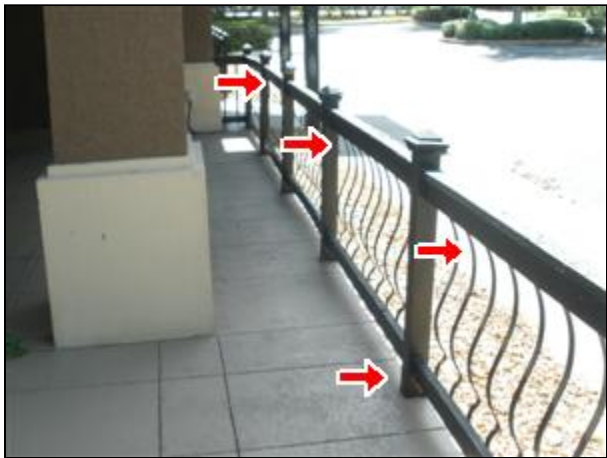
1.4 Picture 1

1.4 Photos 1-8 show the railing around the front patio is in varying degrees of disrepair. Recommend repairs or removal. **FYI** Photo 9 shows an area on the front right that will pond water.

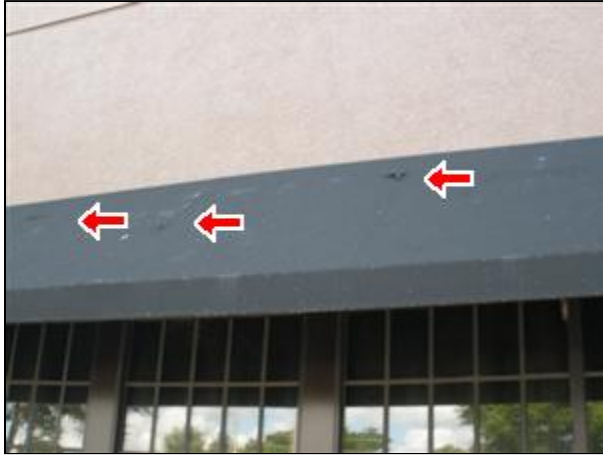
1.6 Picture 1

🏠 1.6 Photos 1-2 show damaged existing canopies. Photo 3 shows tree limbs in contact with the building. Recommend trimming all limbs away from the building.

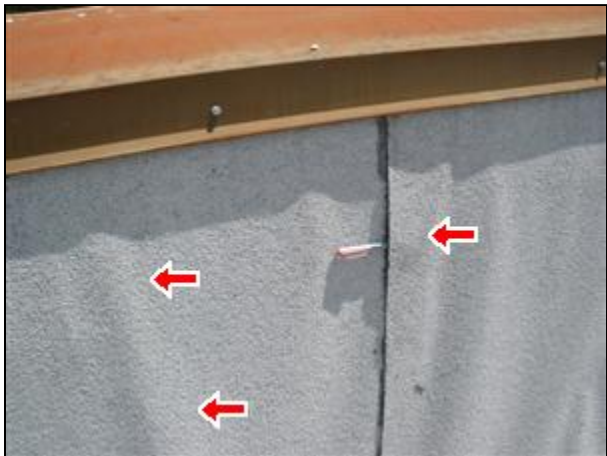
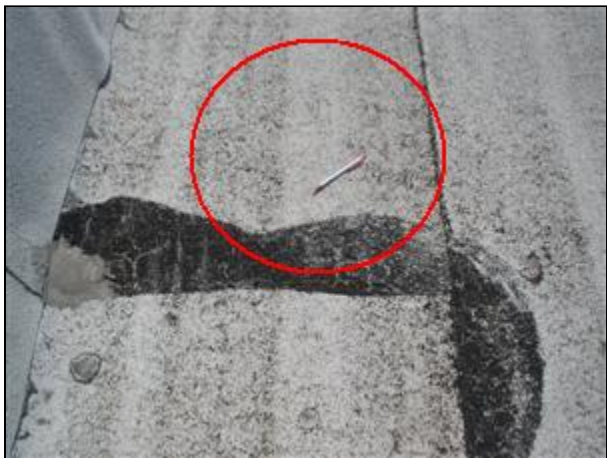
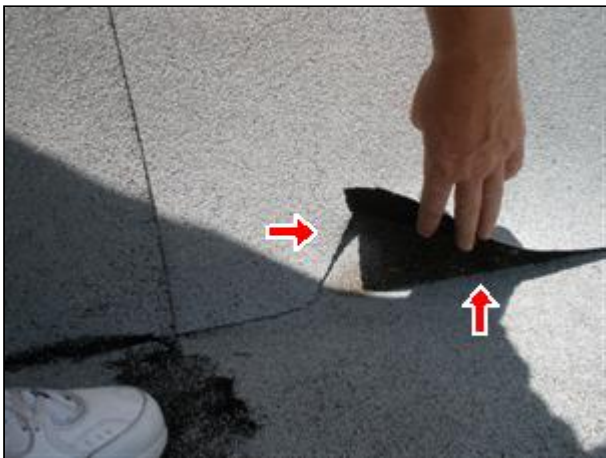
2.0 Picture 1

2.0 Photos show failed lap joints, steam blisters, parapet wrap not fully adhered, and failing past repairs. Recommend repairs as needed by a certified roofing contractor.

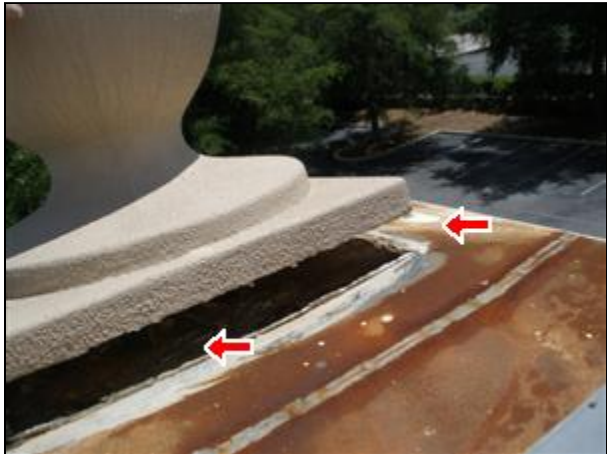
2.1 Picture 1

2.1 While not flashings, these decorative foam elements are not secure and can be blown off the building into the parking lot.

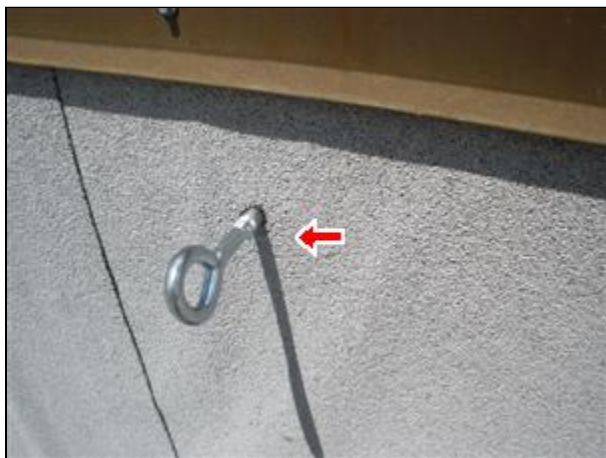
2.2 Picture 1

🏠 2.2 Unsealed penetration in parapet wall covering

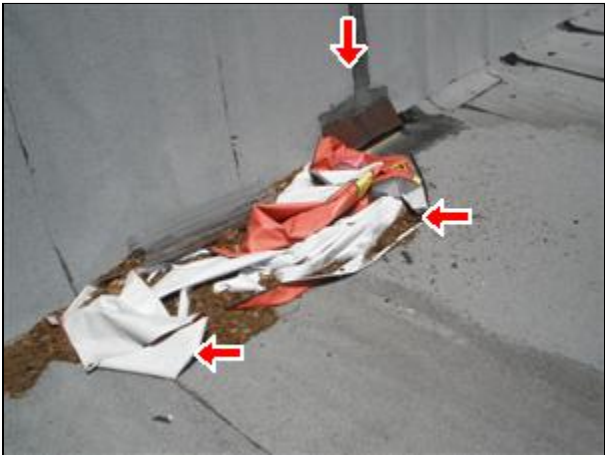
2.4 Picture 1

2.4 Photos 1-3 show miscellaneous debris on upper roof that can block the roof scuppers and cause ponding. Photos 4-7 show stopped up roof drains on lower roof section as well as missing drain covers. Recommend cleaning all debris from all roof surfaces replacing all missing drain covers and making sure all drains are clean and functioning.

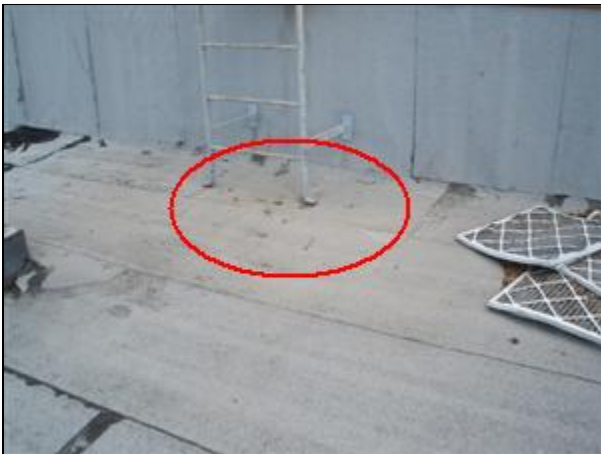
2.5 Picture 1

2.5 This section of roof deck is extremely soft and is in need of repair.

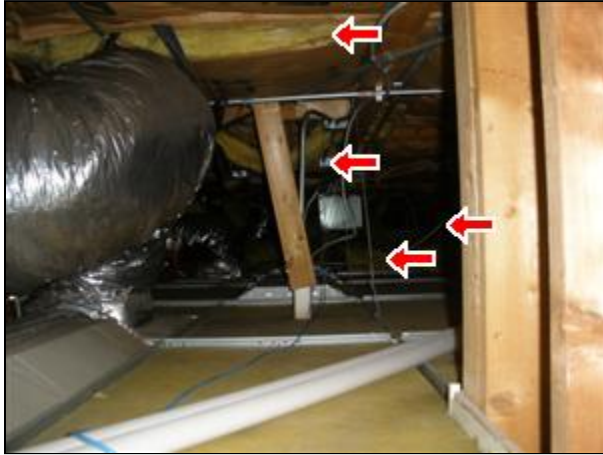
2.6 Picture 1

- 🏠 2.6 There are areas where the insulation has been taken down and not put back in place. Recommend replacing all insulation.

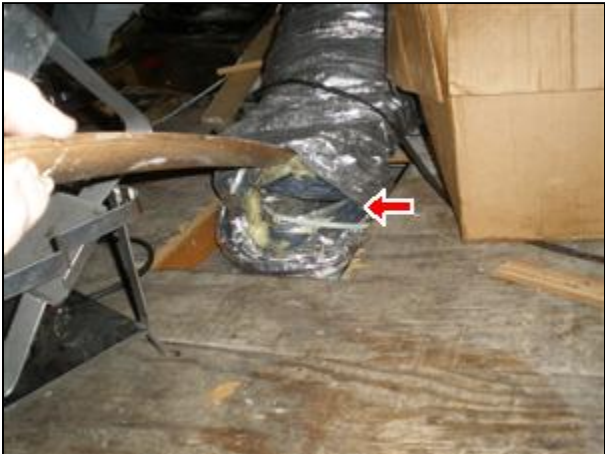
3.6 Picture 1

3.6 Photos 1-2 show 2 damaged ducts. Photo 3 shows dirty ductwork. Recommend checking all duct connections and having the ductwork cleaned.

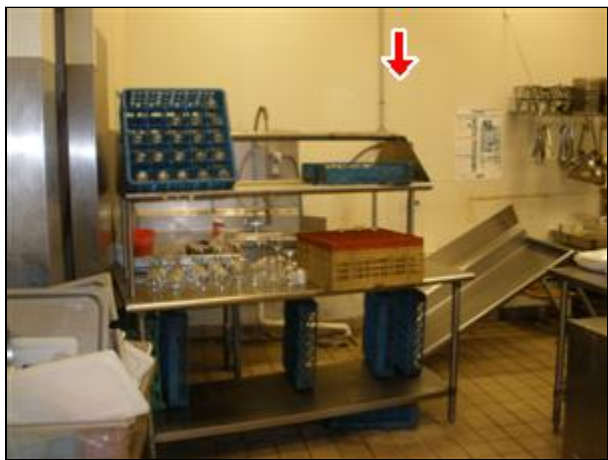
6.8 Picture 1

6.8 No dishwasher on site.

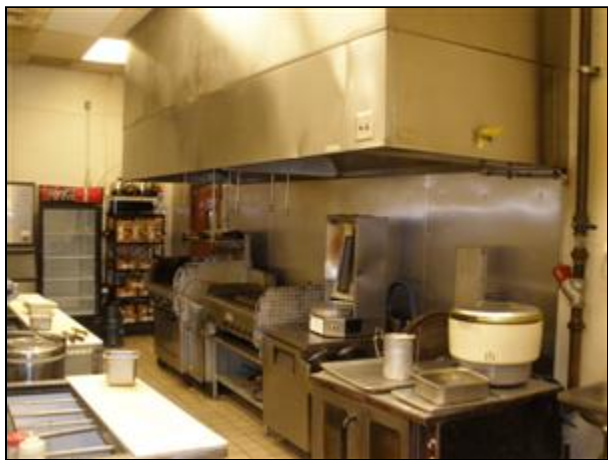
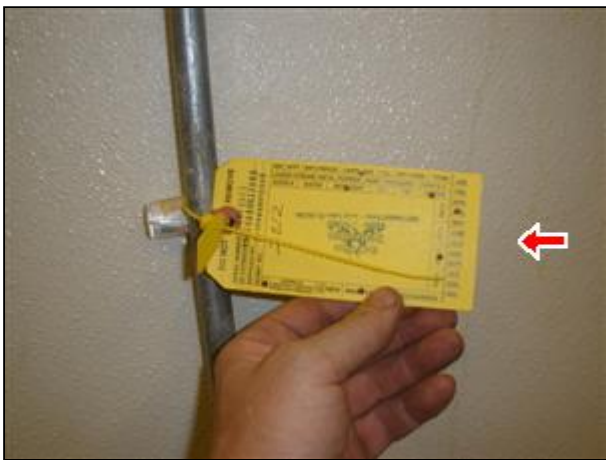
6.9 Picture 1

6.9 The last fire protection inspection for the exhaust hood was April 2010.

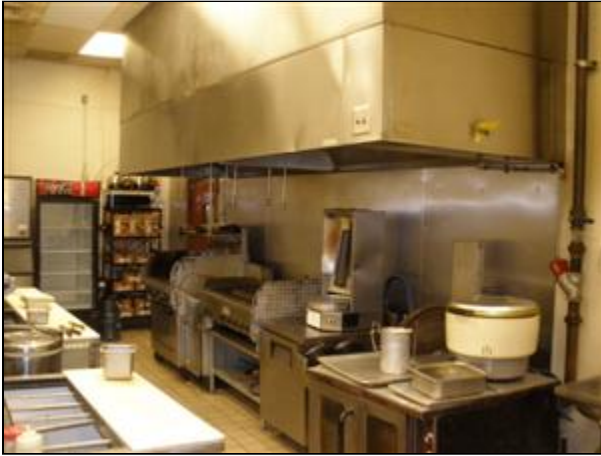
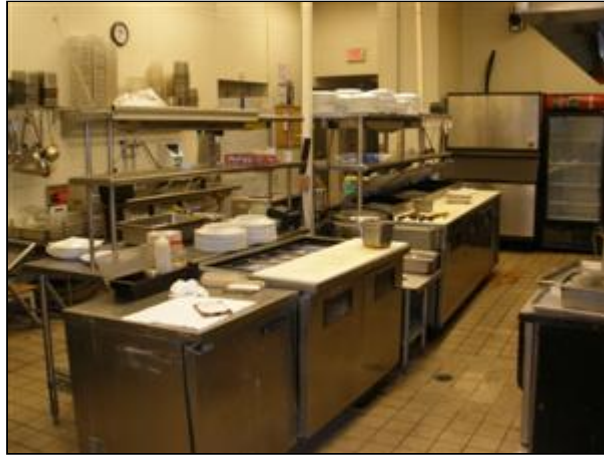
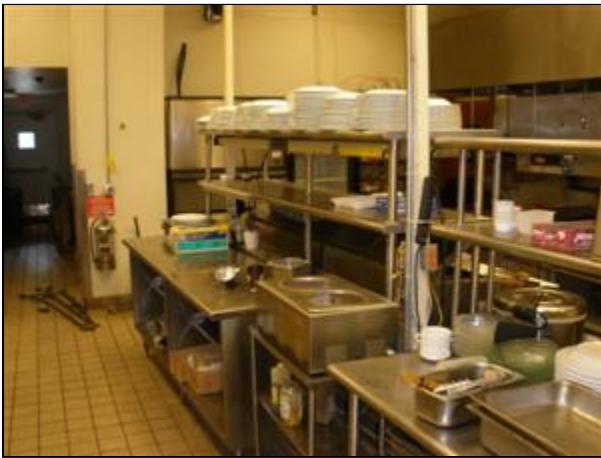
6.10 Kitchen equipment not inspected.

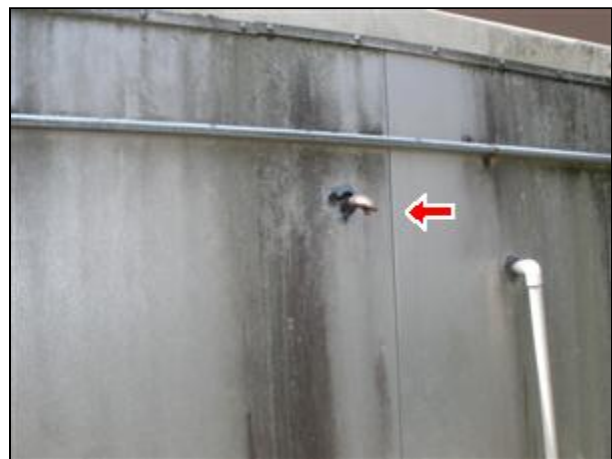
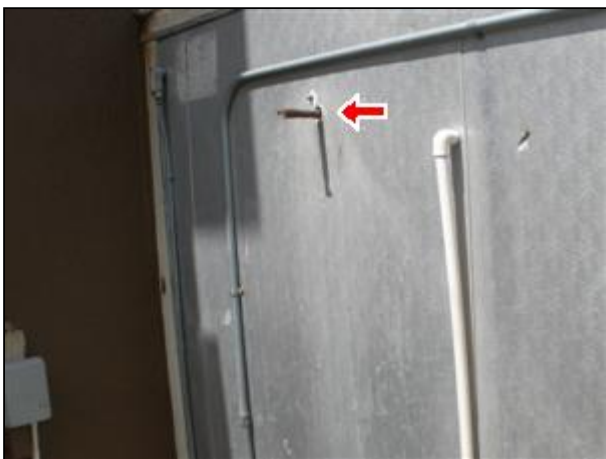
6.13 Picture 1

6.13 While the walk-in coolers were not inspected, it was noted that the condenser sections and refrigerant lines are missing.

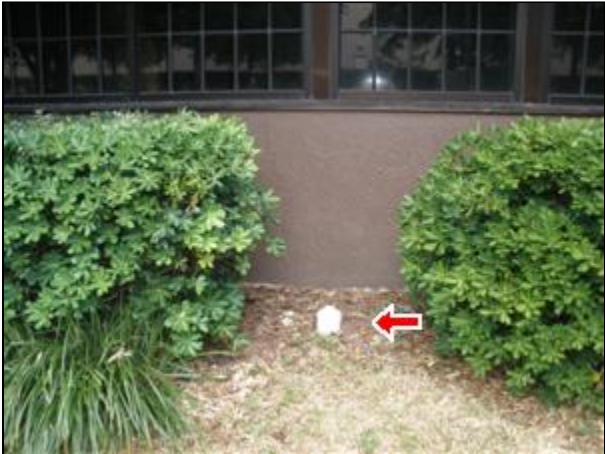
7.0 Picture 1

7.0 Photo 1 shows plumbing clean out. Photo 2 shows sewer access.

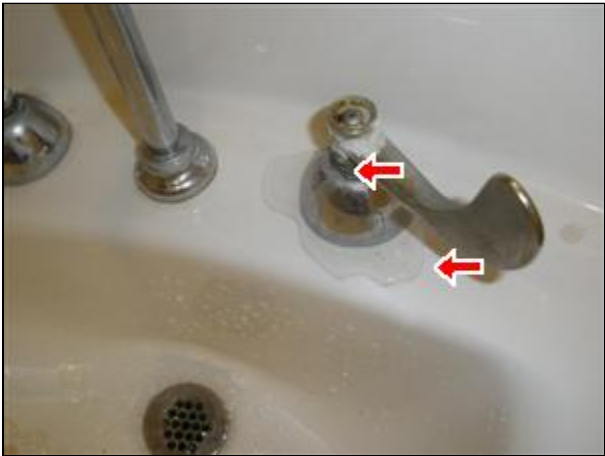
7.1 Picture 1

7.1 Leaking faucets. Recommend repairs as needed.

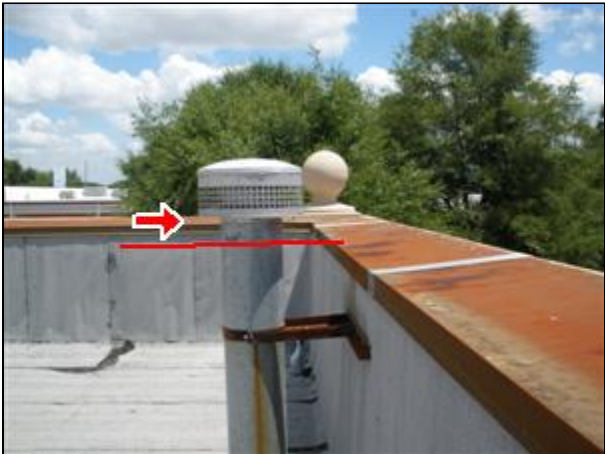
7.2 Picture 1

7.2 Photo 1 shows a boiler flue that is too short. Recommend extending flue. Photo 2 shows hot water circulator pump with signs of over heating. Recommend complete system test when gas is on by a certified plumbing contractor. Photo 2 shows signs of past leak and organic growth. Recommend remediation of all effected material by a certified mold remediation company.

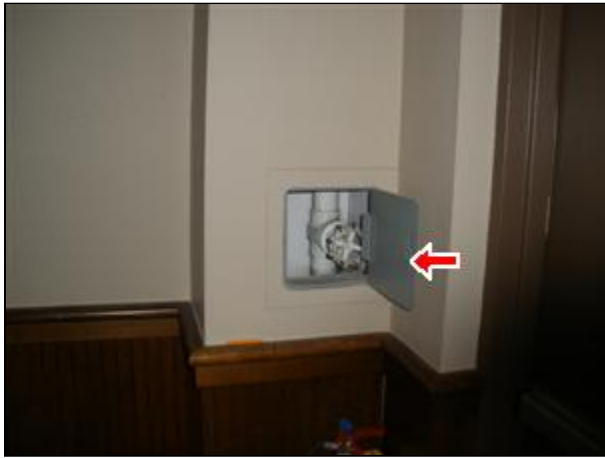
7.3 Picture 1

7.3 Water shut off is near the left side exit by the rest rooms.

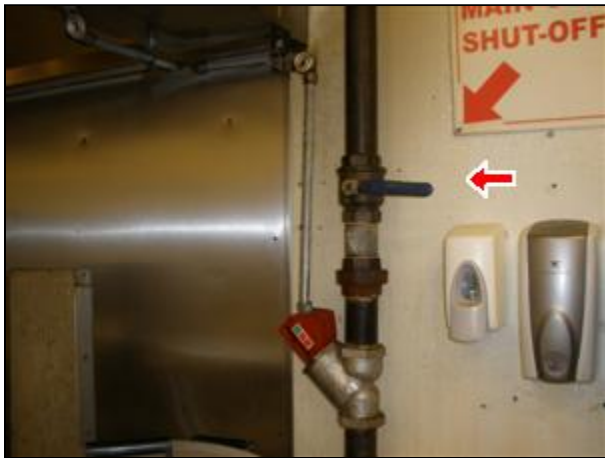
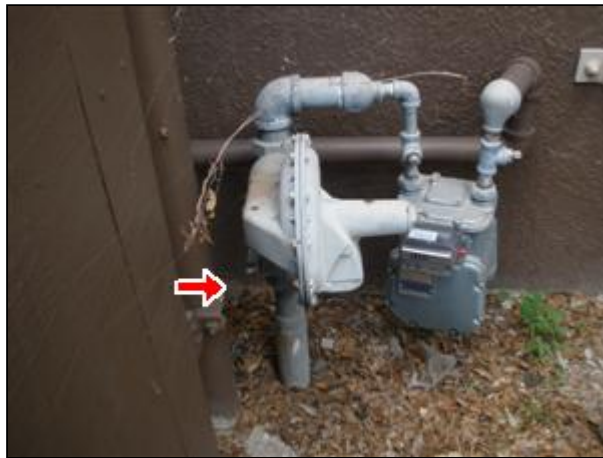
7.5 Gas shut off locations are in the kitchen and in the rear at the meter.

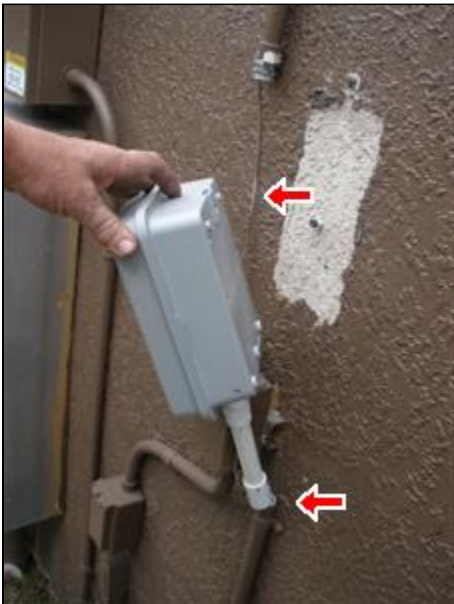
9.3 Picture 1

9.3 Photos show Multiple neutrals terminated under one screw, all neutrals should terminate individually, unprotected cables ends, open and unsecured junction boxes. Photos 10-11 show a loose sprinkler control box with a disconnected rain sensor. Recommend repairs as needed by a certified electrical contractor.

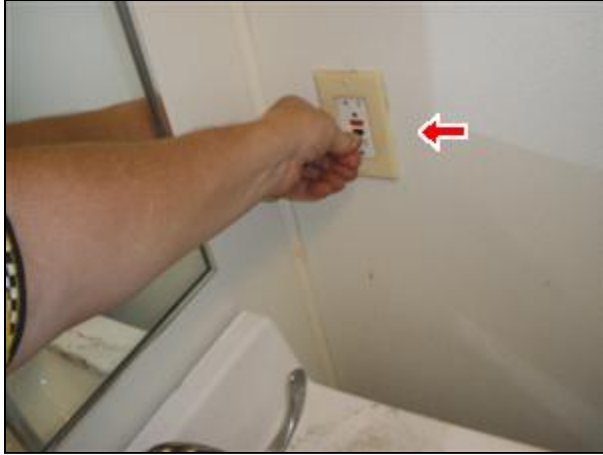
9.5 Picture 1

⚡ 9.5 GFCI's in the staff bathrooms do no operate properly. Recommend repair or replacement by a certified electrical contractor.
